# Manhole Inspection Summary

Manhole # S51C2\_006MH

Insp Date: **6/8/09 10:06 AM**

**Location** Address: **3563 Fairfield Rd.**

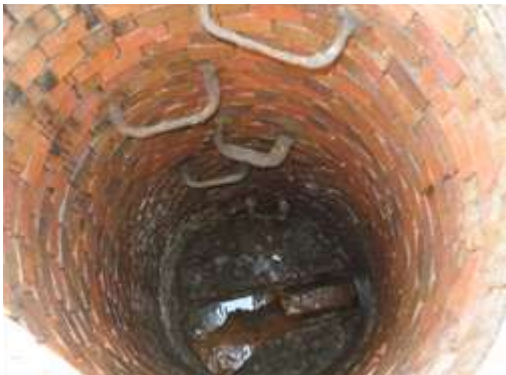
Steps

Count: **7** Missing: **2** ☒ **Corroded**

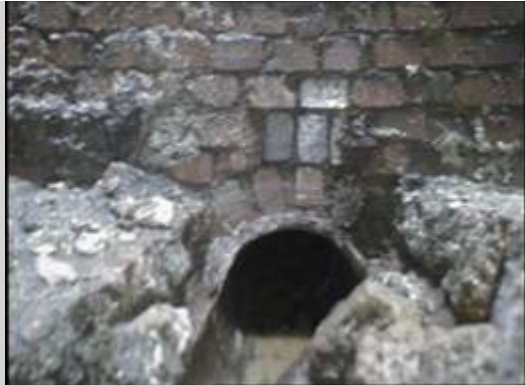
12 O'Clock Outflow

10 in. Circular Gravity Sewer  
Pipe Out @ 12 O'Clock

Pipe Height: **12** (in.) Rod and Bar (Angled)  
Pipe Material: **Clay** ☐ Pipe Lined  
Invert Depth: **12.86** (ft.) Flow Characteristics: **Slow**  
Deposits: ☒ None ☐ **Mud** ☐ Sludge ☐ **Debris** ☐ Grease  
Silt Depth: (in.) Deposits Extent:  
Infiltration: **None** Pipe Seal Cond: **Sound**

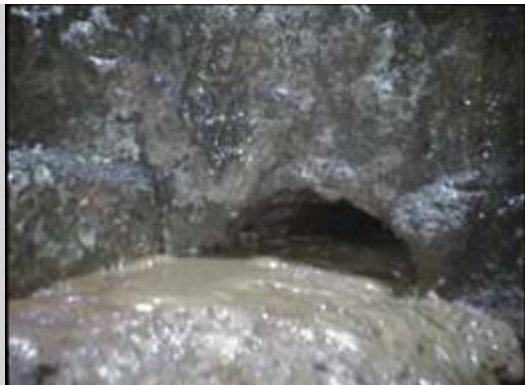
5 O'Clock Inflow

10 in. Circular Gravity Sewer  
Pipe In @ 5 O'Clock

Pipe Height: (in.) Direct (Angled)  
Pipe Material: **Clay** ☐ Pipe Lined  
Invert Depth: **12.74** (ft.) Flow Characteristics: **Slow**  
Deposits: ☐ None ☐ **Mud** ☐ Sludge ☒ **Debris** ☒ **Grease**  
Silt Depth: **5** (in.) Deposits Extent: **Heavy**  
Infiltration: **None** Pipe Seal Cond: **Sound**

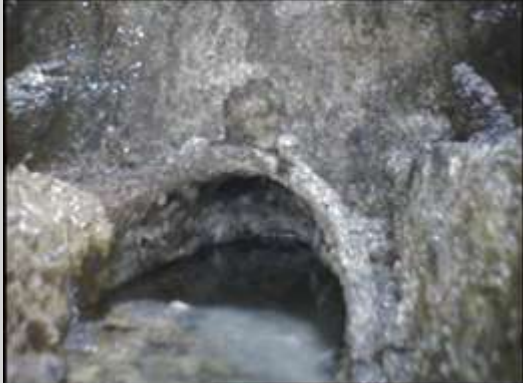
6 O'Clock Inflow

10 in. Circular Gravity Sewer  
Pipe In @ 6 O'Clock

Deposits: ☐ None ☒ **Mud** ☐ Sludge ☒ **Debris** ☐ Grease

Silt Depth: **2** (in.) Deposits Extent: **Medium**
